## INTERIOR BLOWER REPLACEMENT PROCEDURE 664089

Shown below, you can find the procedure that you must follow to replace interior blower cap about Denso code DEA09020

This procedure is available for ERA code 664089.

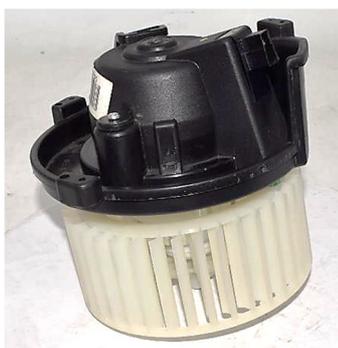
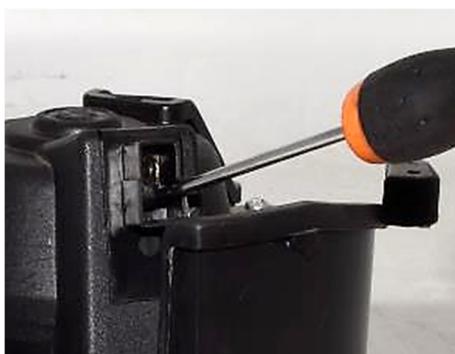
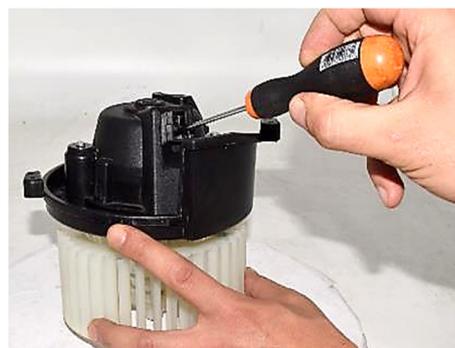
- 1) Dismantling connectors

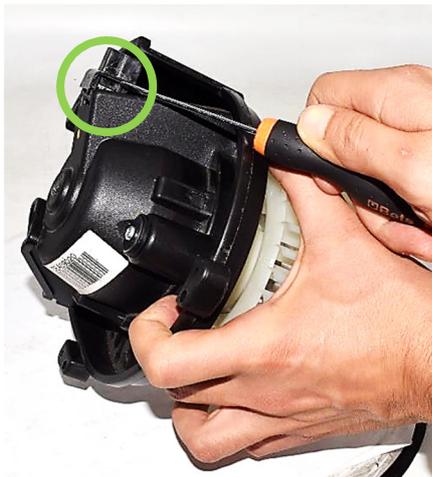
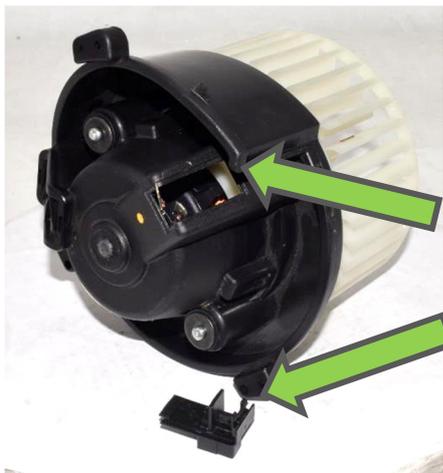
2) Dismantling of connectors compartment (highlighted in green)

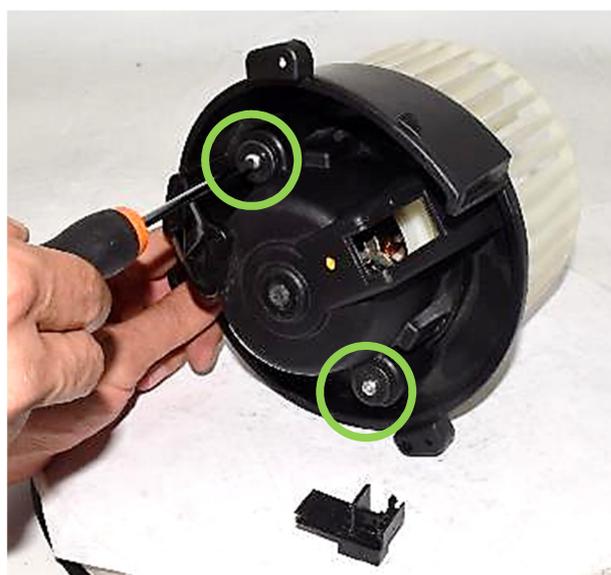
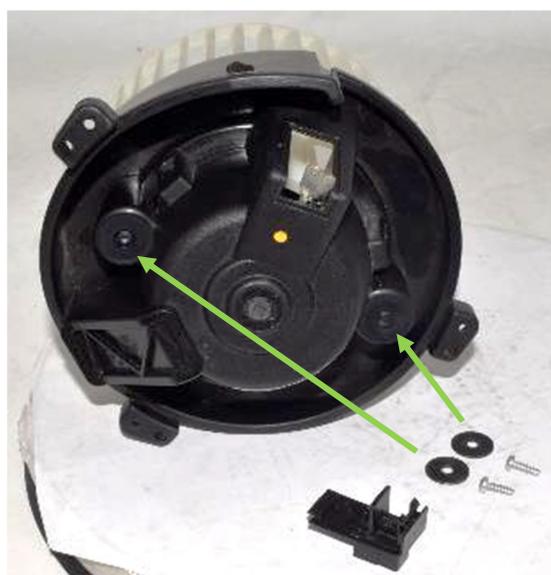
3) Dismantling of anchor points

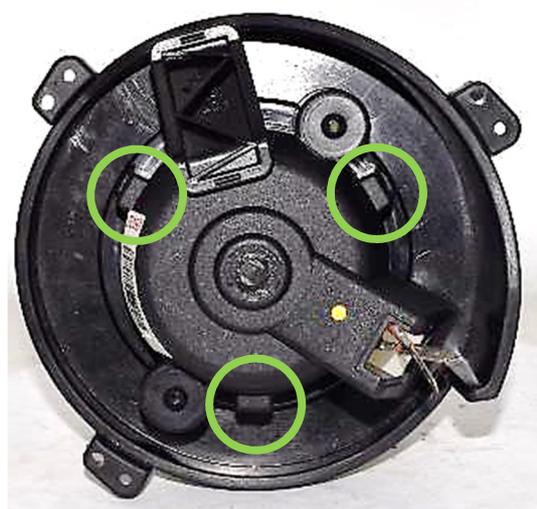
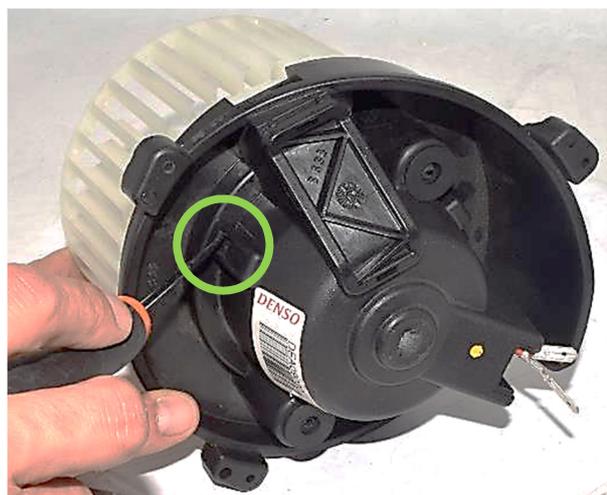
4) Unhooking of the rubber seals

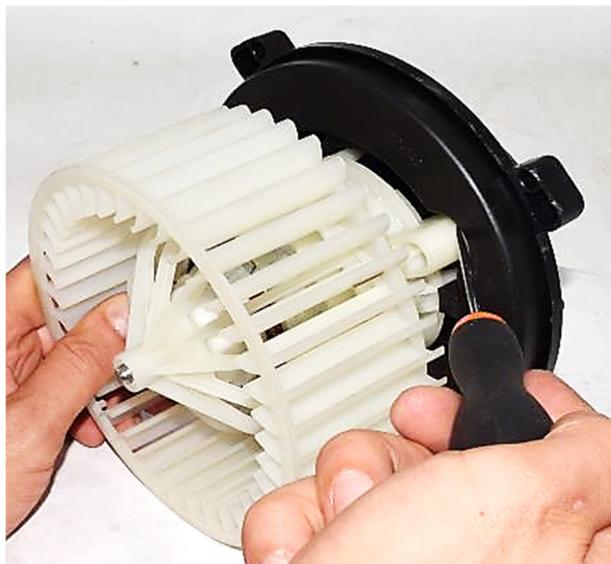
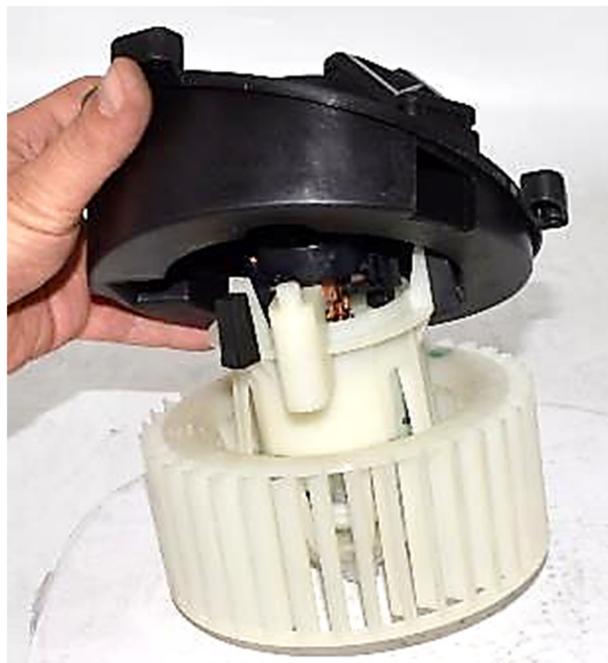
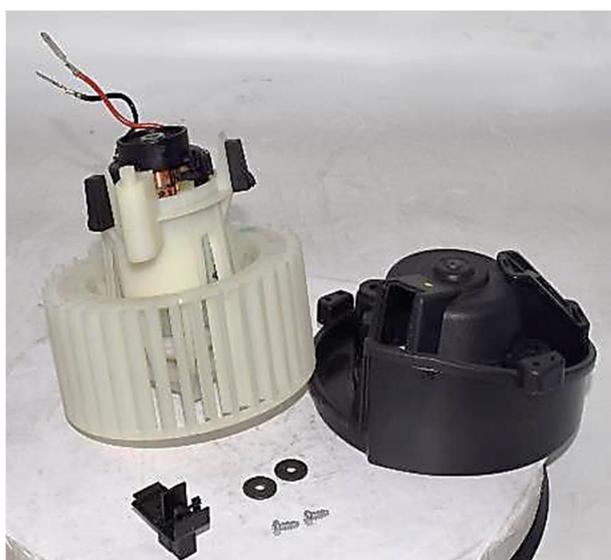
5) Extracting interior blower cap

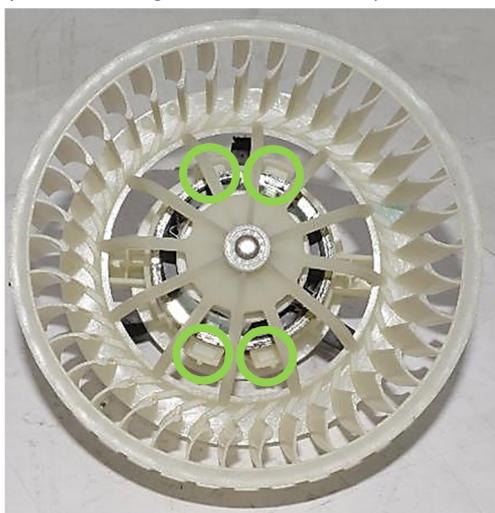
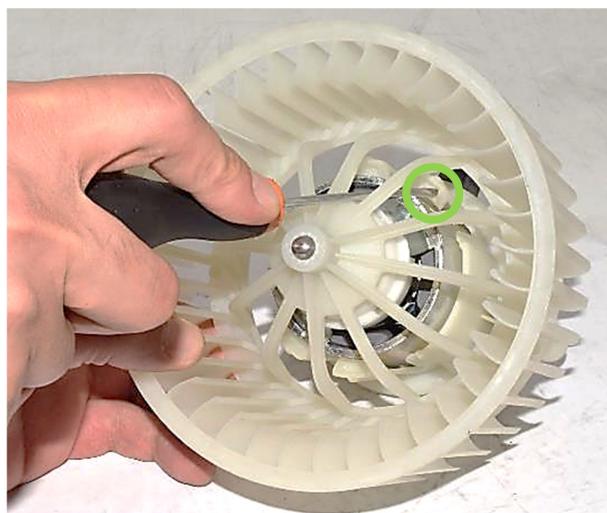
6) Unlocking of the 4 anchor points in interior blower

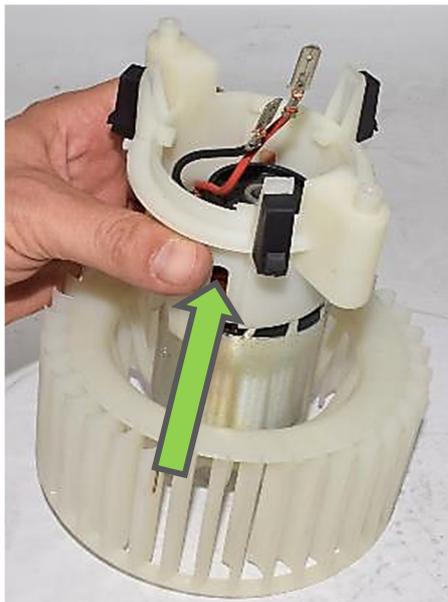
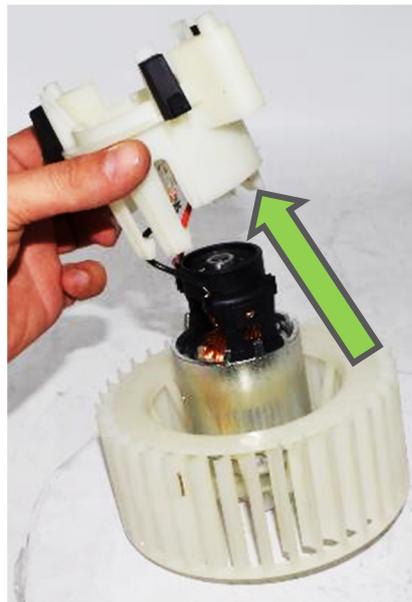
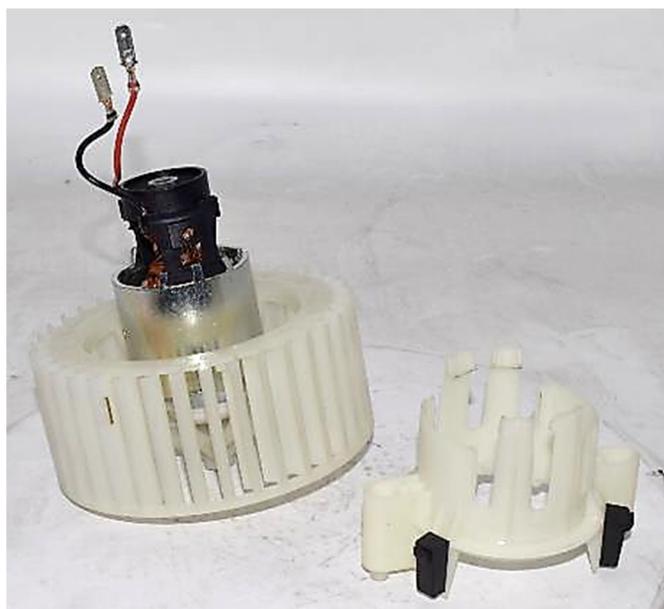
7) Remove the interior blower engine from its compartment

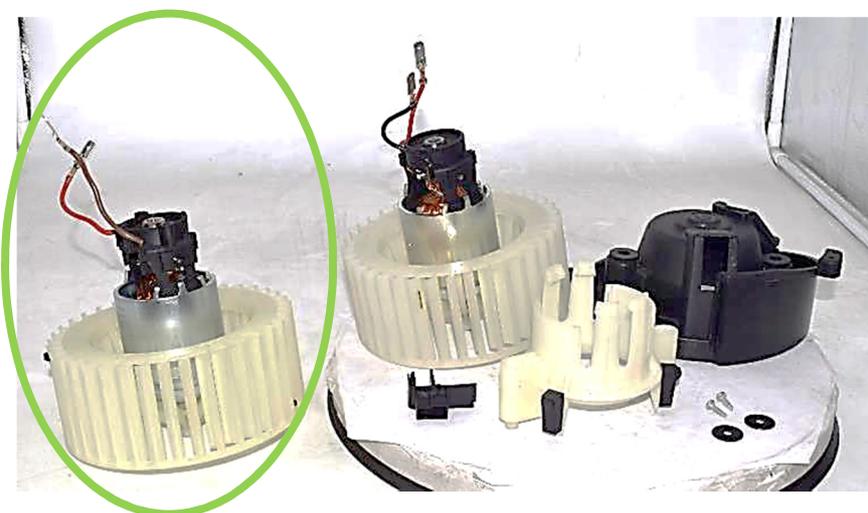
8) Use new interior blower (ERA 664089) and put together each parts, following the reverse process.
